Panna, Low

FRE601201

KOMPAN
Let's play

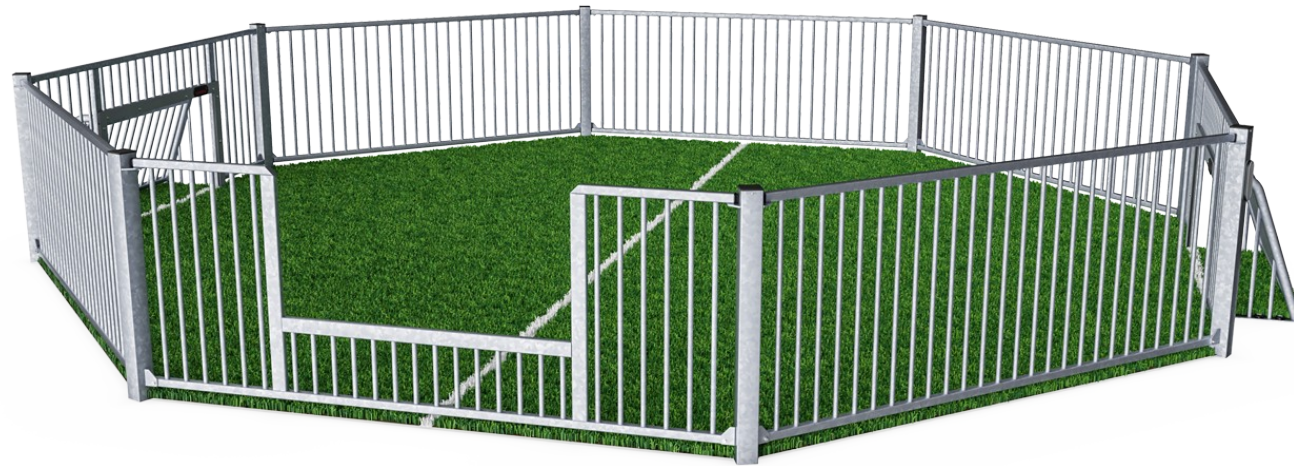
每根竖管之间的距离很小，不会让曲棍球等小球飞出球场。通过将管子嵌入钢架中，Panna 球场是一种极防破坏的结构，可以放置在任何社区中。这种透明设计便于观众观看比赛。曲棍球场入口处足够低，方便观众进入，但又能保证大多数球都在比赛中，确保比赛快速进行。

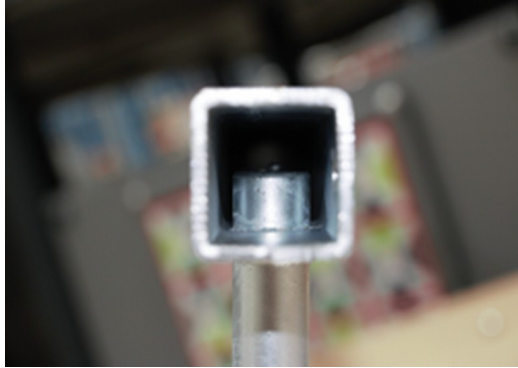
Ø21.3mm x 2mm 圆管嵌入钢面板中，避免裂纹，防止圆管戳出钢框架。构建了一个非常坚固的，防破坏的解决方案。

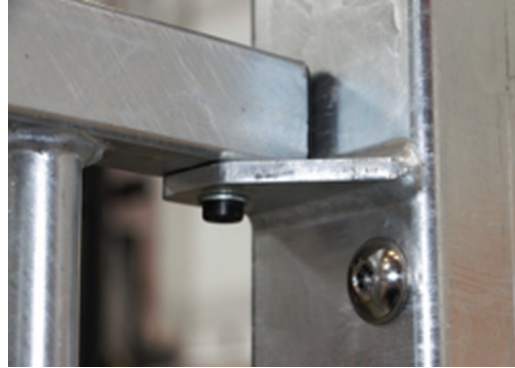
所有的钢构件都是由碳钢焊接而成，符合 EN ISO 5817，热浸镀锌符合 ISO1461。这个工艺确保结构在任何情况下都能得到良好的保护。

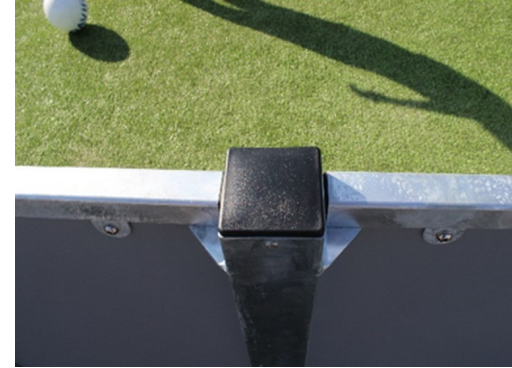
立柱由 80 x 80 x 3mm 的整体材料模制而成，水平方向为 6mm 焊接法兰。这将提供一个简单的安装程序和牢固的结构。低密度聚乙烯柱帽与盲铆钉连接。

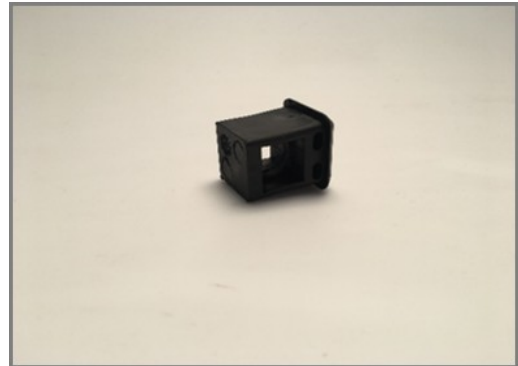
每个面板有 4 个热塑硫化插头连接面板。这些接头减少了振动，因此降低了噪音水平。因为有预先装配的螺母，接头也将简化安装程序。

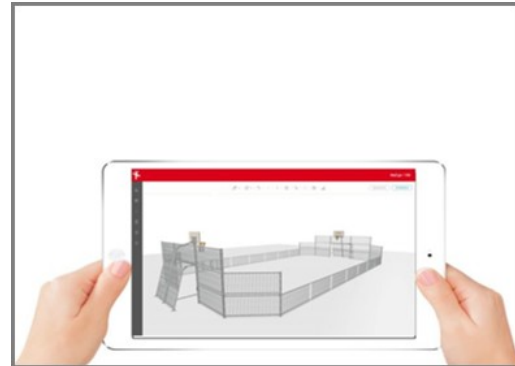
KOMPAN 多功能运动场 (MUGA) 设计上充满灵活性。可以轻松改变大小，高度，面板，入口和球筐，以创建一个适合环境，预算和用途的多功能场地。

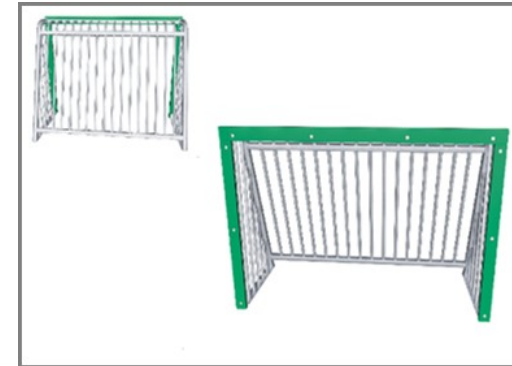
Panna 的球门尺寸 118x68cm，Ø21.3mm 圆管之间的垂直距离是 68 毫米，大小足以让所有的球保持在球场里面。球门用彩色的 HDPE 条框起来以突出球筐。

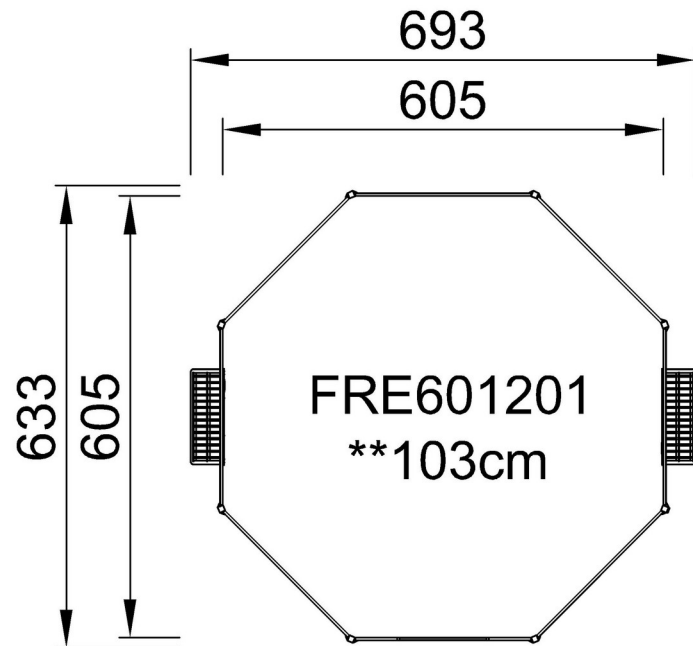
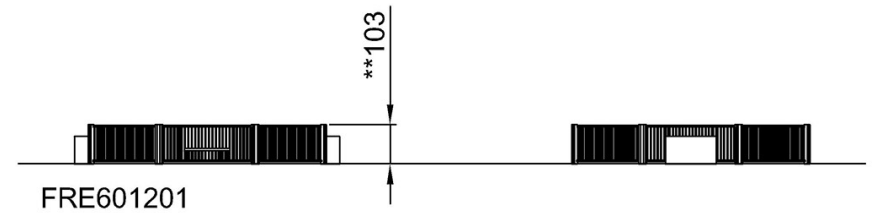
最大跌落高度 | 总高度 | 安全区域

最大跌落高度 | 总高度
